## Lift Brake Release Adjustment Procedure

Whenever you have a problem raising/lowering the unit, it could be due to the brake pressure plate gap adjusted wrong. The correct procedure to get the proper release gap is as follow;

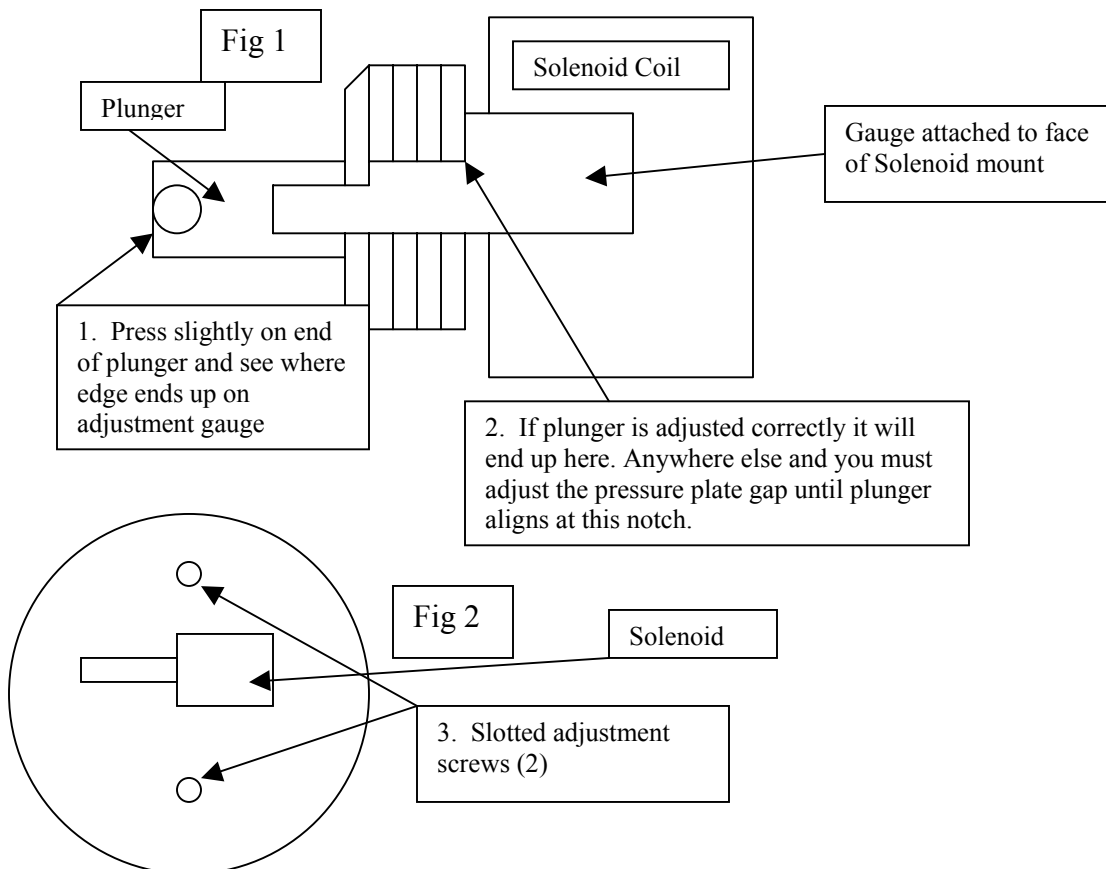
1. Remove power to the lift motor by pressing E-Stop button in on command console.
2. Verify the unit is all the way down and brake release knob is horizontal.
3. Remove two cap nuts top and bottom of rear cover.
4. Pull cover off of the motor end. This exposes the release solenoid and adjustment screws. Careful not to rip electrical leads going to the release solenoid.
5. Using Fig. 1, press inward slightly on the center plunger (1) of the solenoid and see where the inner edge aligns with adjustment gauge.
6. If the edge of the plunger meets the correct gauge setting then you have another problem why lift motor does not respond correctly.
7. If the edge of release plunger is anywhere else than the settings notch, you must adjust the gap of the release pressure plate by turning adjustment screws (3) of figure #2 CW to increase the gap of plunger, CCW to decrease gap on plunger.

**NOTE! To change the plunger gap takes very little turning of the adjustment screws. Usually only about 1/8 to 1/3 turn of the screw. Both screws must be turned the same amount.**

8. When plunger is correctly on the gauge, reinstall the cover and replace the cap screws holding the cover. Again verify release knob is horizontal.
9. Test unit by operating unit in the Mitsubishi Client Program.
